BELZONA REFURBISHES TRAIN DIESEL TANK

ID: 6066

Industry: *Transport*
Application: *TCC-Tanks and Chemical Containment Areas*
Substrate: *Steel*
Products: ** Belzona 1121 (Super XL-Metal) ,*

Customer Location: *Leicestershire, UK*
Application Date: *2015*

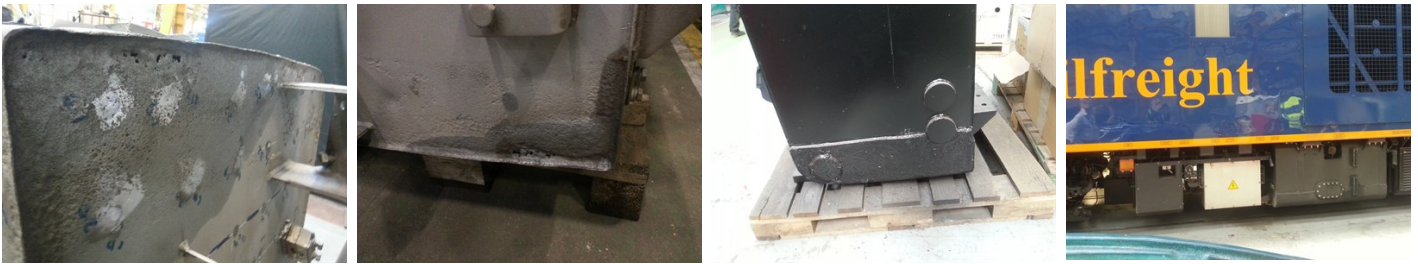
Photograph Descriptions

Moisture was entering the gap between the steel tank and the fibreglass coating, resulting in corrosion damage and leading to pitting and holes.

- * The corroded diesel tank before treatment ,
- * Lower portion of the tank prior to treatment ,
- * Tank plate-bonded with Belzona 1121 and coated in GRP ,
- * Repaired tank refitted to train ,

Application was carried out in accordance with Belzona Know-How System Leaflet TCC-1. The fibreglass coating was grit blasted away. Metal plates were then cold bonded over the defects using Belzona 1121 and the tank then re-coated with GRP, painted black and refitted onto the trains.
