BELZONA REPAIRS LEAKING HEXANE PROCESS PIPE

ID: 6068

Customer Location: Adhesive Manufacturer, Cramlington, UK

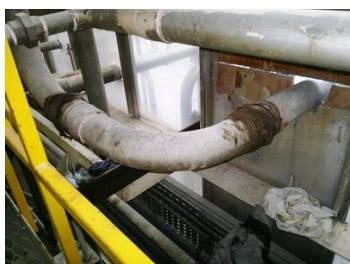
Customer had been using a temporary pipe wrap which did not offer a permanent solution. Leaking of the pipe was a Health & Safety issue due to the volatility of the Hexane product flowing through the process pipework.

- * Temporary pipe wrap ,
- * Removal of temporary pipe wrap ,
- * Permanent Belzona repair ,
