# BELZONA RESTORES FAN BLADES TO FINE FETTER

Industry: *Chemical & Petrochemical*  
Application: *FBC-Fans, Blowers and Compressors*

Customer Location: *Refinery, Scotland*  
Application Date: *2013*

Blades from a Fin Fan cooler

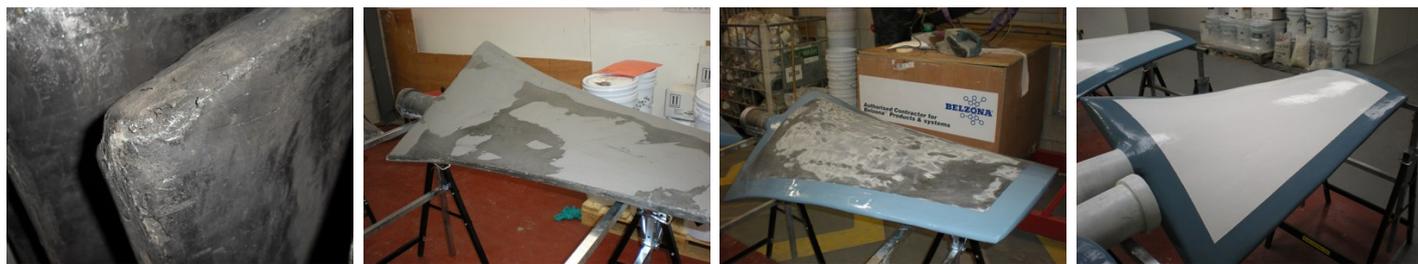
*UV radiation and impingement erosion had worn down the leading edges of the fan blades, damaging the fibreglass construction.*

- \* The damaged fan blades ,
- \* Damaged areas restored with Belzona 1121 ,
- \* Leading edges marked off and coated with Belzona 1341 ,
- \* Completed application ,

Application was carried out in accordance with Belzona Know-How System Leaflet FBC-1. The damaged areas were rebuilt and

reinforced with Belzona 1121 incorporating Belzona 9341. An area of roughly 75mm around the leading edges of each fan blade were coated with Belzona 1341 to provide optimum erosion resistance. Finally the Belzona 5111 system was applied over the blades to provide UV resistance to the underlying fibreglass.
