# RISER BOOT SEALED WITH BELZONA

ID: 607

Application: SOS-Ships and Offshore Structures

Customer Location: Oil and Gas Industry, North Sea, Norway

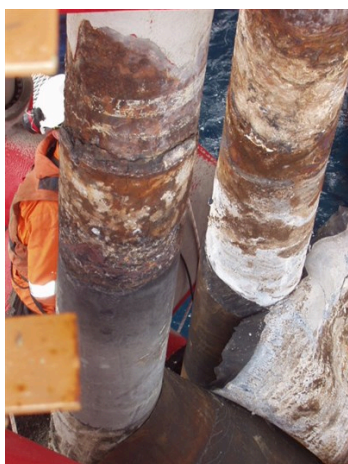
The customer was concerned that after replacing damaged neoprene, water would penetrate between the riser and the cladding onto glassflake coating and cause disbondment.

- \* Removing the old neoprene ,
- \* Applying the Belzona 2121 onto new neoprene ,
- \* Completed application ,
- \* Inspection in 2010 ,

The application was carried out in accordance with Belzona Know-How System Leaflet SOS-21. Application was carried out using rope access to suspend operatives beneath the platform. The Belzona 2121 system was applied to encapsulate the new neoprene cladding to glassflake coating on the riser.

Belzona was chosen due to its high adhesion to both neoprene and glassflake. Another advantage for the applicators was the relative ease of application of the Belzona products. As of February 2015 the application is still in perfect condition.
