IMPELLED TO ACTION

ID: 6070

Industry: Power
Application: FBC-Fans, Blowers and Compressors

Customer Location: Lilla Edet
Application Date: September 2014

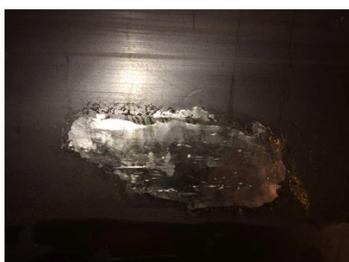
Cavitation had caused damage to a number of locations on the impeller blade of a Swedish hydropower plant. The damage reduced plant efficiency, and if untreated could ultimately have led to total mechanical failure.

Damage to the impeller

Impeller blade suffering from serious cavitation damage in approximately 15 places.

The affected area was brush-blasted to provide a suitable substrate surface. One layer of Belzona 1311 was then applied and left to cure, followed by two successive layers of Belzona 1341.

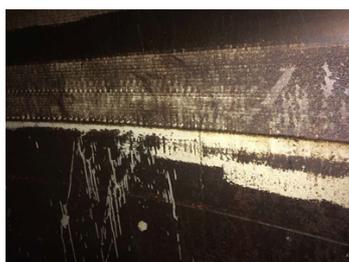
Scratch damage and wearing

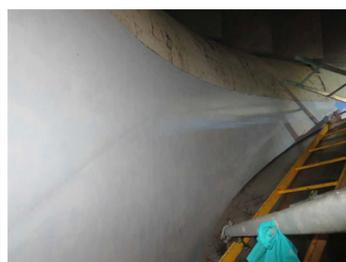
Belzona 1311 Ceramic R-Metal topped with Belzona 1341

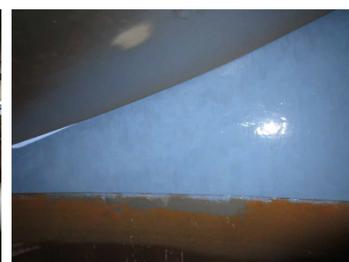
Second and final coat of Belzona 1341

The repair was a rapid one, with the preparation and three layers applied over the course of three days. Thanks to the rapid cure times of Belzona systems, client downtime was minimised. The highly durable and cavitation-resistant properties of Belzona® 1341 mean that the impeller is now protected for the foreseeable future.
