IMPELLED TO ACTION

Industry: Power
Application: FBC-Fans, Blowers and Compressors

Customer Location: Lilla Edet
Application Date: September 2014

Substrate: Carbon steel
Products: Belzona 1311 (Ceramic R-Metal), Belzona 1341 (Supermetalgilde)

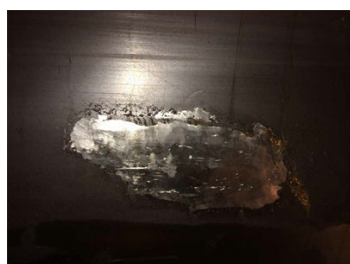
Cavitation had caused damage to a number of locations on the impeller blade of a Swedish hydropower plant. The damage reduced plant efficiency, and if untreated could ultimately have led to total mechanical failure.

Damage to the impeller

Impeller blade suffering from serious cavitation damage in approximately 15 places.

The affected area was brush-blasted to provide a suitable substrate surface. One layer of Belzona 1311 was then applied and left to cure, followed by two successive layers of Belzona 1341.

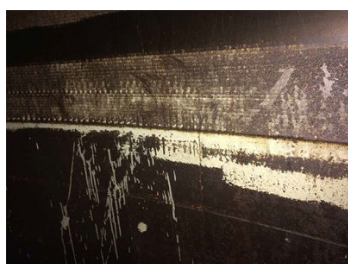
Scratch damage and wearing

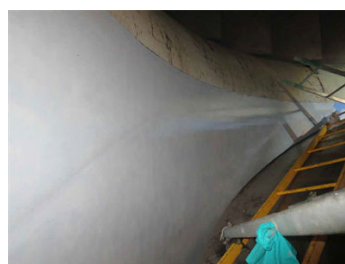
Belzona 1311 Ceramic R-Metal topped with Belzona 1341

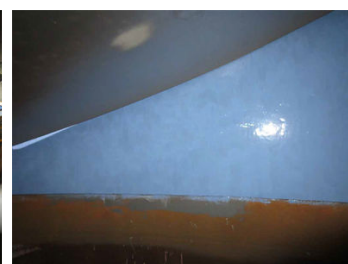
Second and final coat of Belzona 1341

The repair was a rapid one, with the preparation and three layers applied over the course of three days. Thanks to the rapid cure times of Belzona systems, client downtime was minimised. The highly durable and cavitation-resistant properties of Belzona® 1341 mean that the impeller is now protected for the foreseeable future.
