IMPELLED TO ACTION

ID: 6070

Industry: Power

Application: FBC-Fans, Blowers and Compressors

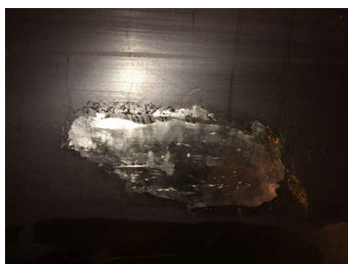
Damage to the impeller

Impeller blade suffering from serious cavitation damage in approximately 15 places.

The affected area was brush-blasted to provide a suitable substrate surface. One layer of Belzona 1311 was then applied and left to cure, followed by two successive layers of Belzona 1341.

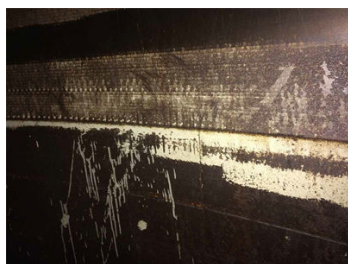
Scratch damage and wearing

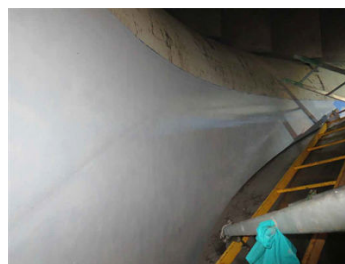
Belzona 1311 Ceramic R-Metal topped with Belzona 1341

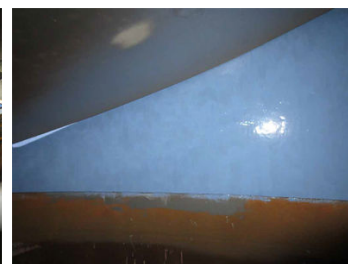
Second and final coat of Belzona 1341

The repair was a rapid one, with the preparation and three layers applied over the course of three days. Thanks to the rapid cure times of Belzona systems, client downtime was minimised. The highly durable and cavitation-resistant properties of Belzona® 1341 mean that the impeller is now protected for the foreseeable future.
