# IMPELLED TO ACTION

ID: 6070

Industry: Power  
Application: FBC-Fans, Blowers and Compressors

Customer Location: Lilla Edet  
Application Date: September 2014

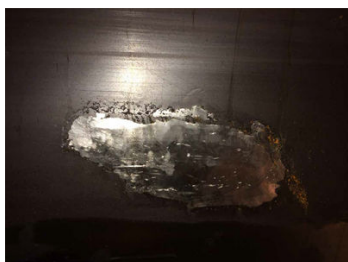
Cavitation had caused damage to a number of locations on the impeller blade of a Swedish hydropower plant. The damage reduced plant efficiency, and if untreated could ultimately have led to total mechanical failure.

Damage to the impeller

The affected area was brush-blasted to provide a suitable substrate surface. One layer of Belzona 1311 was then applied and left to cure, followed by two successive layers of Belzona 1341.

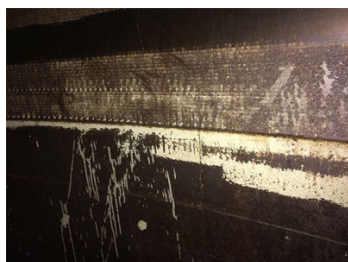
Scratch damage and wearing

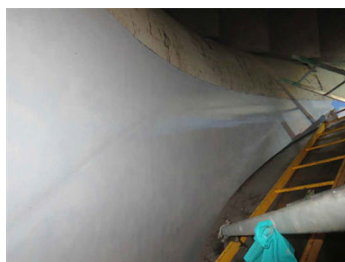
Belzona 1311 Ceramic R-Metal topped with Belzona 1341

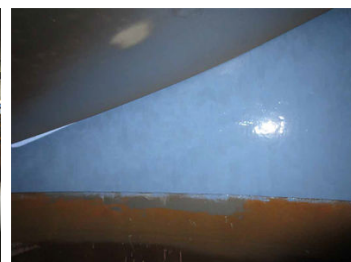
Second and final coat of Belzona 1341

The repair was a rapid one, with the preparation and three layers applied over the course of three days. Thanks to the rapid cure times of Belzona systems, client downtime was minimised. The highly durable and cavitation-resistant properties of Belzona® 1341 mean that the impeller is now protected for the foreseeable future.
