# BELZONA REBUILDS AND PROTECTS TURBINE RUNNER

Customer Location: Hydroelectric Plant, Jokkmokk, Sweden  
Application Date: 2014

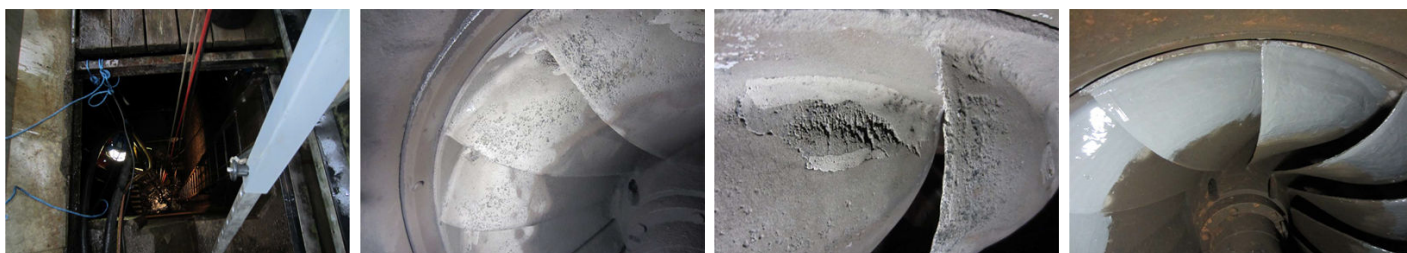
## Photograph Descriptions

- \* Turbine housing entrance ,
- \* Cavitation damage to the runner ,
- \* Close-up of the damage ,
- \* Completed application ,

Two impeller runner blades had suffered severe cavitation and erosion damage.

Application was carried out in accordance with Belzona Know-How System Leaflets CEP-1 and CEP-3. Surfaces were grit blasted prior to rebuilding with Belzona 1311 to restore profiles and coating with Belzona 1321 to provide long-term protection.
