BELZONA REBUILDS AND PROTECTS TURBINE RUNNER

Customer Location: Hydroelectric Plant, Jokkmokk, Sweden
Application Date: 2014

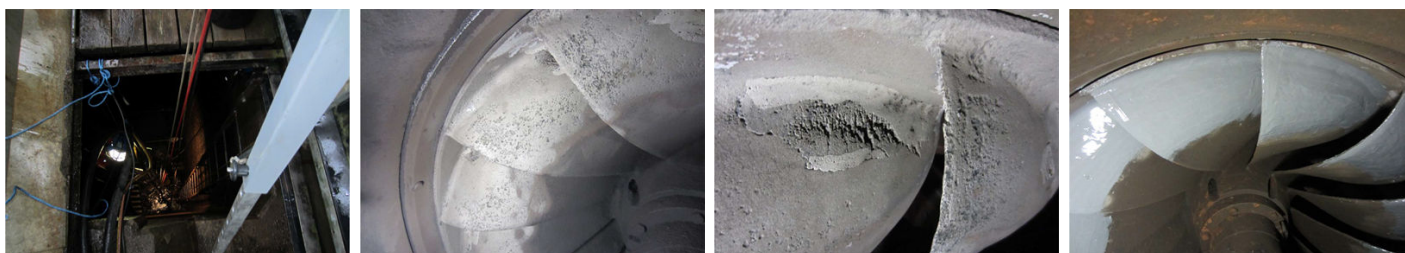
Photograph Descriptions

Constant use had damaged the vulnerable cast iron substrate of the impellers. The client needed a quick, long-term solution to avoid downtime to their plant.

- * Turbine housing entrance ,
- * Cavitation damage to the runner ,
- * Close-up of the damage ,
- * Completed application ,

Two impeller runner blades had suffered severe cavitation and erosion damage.

Application was carried out in accordance with Belzona Know-How System Leaflets CEP-1 and CEP-3. Surfaces were grit blasted prior to rebuilding with Belzona 1311 to restore profiles and coating with Belzona 1321 to provide long-term protection.

The Belzona solution is cold-applied and simple to use, which meant that repairs and the application could be performed in-situ, avoiding costly disassembly work which would force a long downtime period. Force curing Belzona allowed the plant to return to operational status as quickly as possible, whilst the Belzona application offers a long-term, durable solution.
