# BELZONA SEALS LEAKING HEAT EXCHANGER PIPE

ID: 6075

Customer Location: Veneer Manufacturer, Northumberland,  
UK

Application: VPF-Valves, Pipes and Fittings

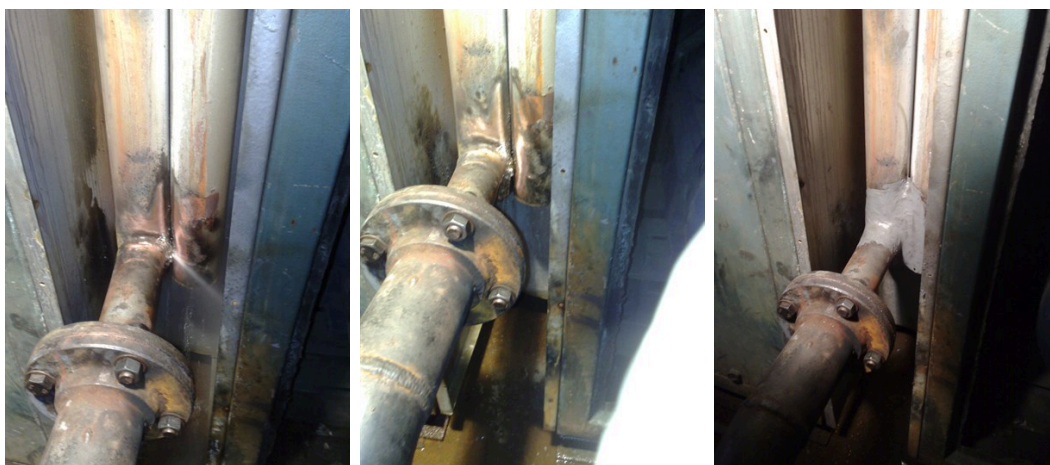
Customer had made several attempts to braze the leak without success due to the thin wall nature of the copper pipework. The nature of the continuous leak was creating a safety hazard.

- \* Leaking pipework ,
- \* Pipework manually prepared ,
- \* Pipework repaired ,

Pin hole leak on T Junction of the heat exchanger pipework.

The application was carried out in accordance with Belzona Know-How System Leaflet VPF-11 after draining the system.

The repair was carried out with minimal downtime and negated hot work, which had been tried unsuccessfully the first time. The

Belzona solution removed the Health & Safety risk whilst also providing a permanent repair.
