# BELZONA RESTORES AND PROTECTS CORRODED PIPEWORK

**Customer Location:** Steel plant, Czech Republic  
**Application Date:** 2012

Corrosion on the inlet and outlet pipes of the cooling circuit

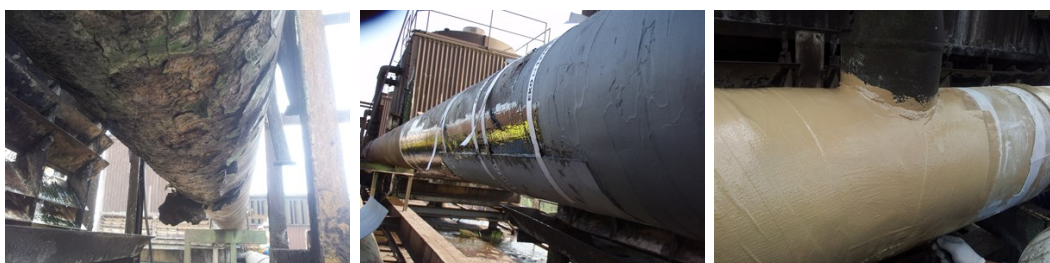
The lower part of the outer casing of the cooling circuit pipe was heavily corroded, causing a weakening of the actual mantle and localised coolant leak.

- \* Corroded pipework ,
- \* Belzona 1111 and reinforcing metal plates applied ,
- \* Pipeline coated with Belzona 5811 incorporating Belzona 9341 ,

Application was carried out in accordance with Belzona Know-How System Leaflets VPF-2 and VPF-11. After surface preparation, the badly corroded areas were repaired with Belzona 1111 and reinforcing metal plates. The pipeline was then treated with the Belzona 5831 and Belzona 5811 incorporating Belzona 9341 to provide long term corrosion protection.
