BELZONA TACKLES AN EXPLOSIVE SITUATION

ID: 6078

Customer Location: Steel producer, Czech Republic
Application Date: October 2015

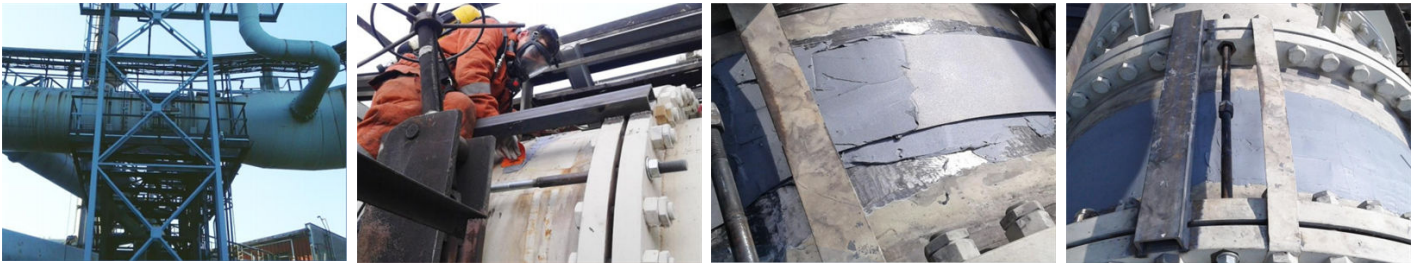
Photograph Descriptions

Pipeline had developed a crack which was leaking gas into the atmosphere. The repair had to be performed live. The intake pipe had a diameter of 2,000mm and had developed a crack 2,500mm long and 2mm wide.

- * The damaged pipework ,
- * Applying the first seal of Belzona 1211 ,
- * Main layer of Belzona 1111 and sheet applied ,
- * Completed application ,

Application was carried out in accordance with Belzona Know-How System Leaflet VPF-11. To provide an initial seal to the crack, the fast-setting Belzona 1211 was deployed, stopping the leak and eliminating the risk of explosion. This allowed the surface to be prepared, and the substrate was ground to achieve the optimum surface profile. Belzona 1111 was then applied in two layers incorporating Belzona 9341.
