# BELZONA SAVES OIL COOLER FROM SCRAP HEAP

Industry: Power  
Application: HEX-Heat Exchangers  
Substrate: Steel  
Products: \* Belzona® 1311 (Ceramic R-Metal) ,  
\* Belzona® 1321 (Ceramic S-Metal) ,

Customer Location: Coal fired power station - Germany  
Application Date: 2004

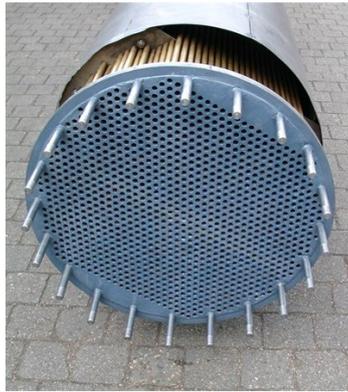
After 40 years in service the oil coolers were suffering from severe corrosion.

- \* Corroded tubesheet ,
- \* Completed tubesheet ,
- \* Tubesheet at opposite end ,
- \* Close-up ,

The corrosion damage was rebuilt with Belzona® 1311 and coated with Belzona® 1321 in accordance with Belzona System Leaflets HEX-1 and HEX-3.

The cooler had been in service for nearly 40 years and the manufacturer had recommended replacement. The repair included reseating the retaining bolts and cost a fraction of replacement.
