# BELZONA UPGRADES BASEMENT TO PLANT ROOM USE

ID: 6086

**Customer Location:** University, Cambridge, UK  
**Application Date:** February 2016

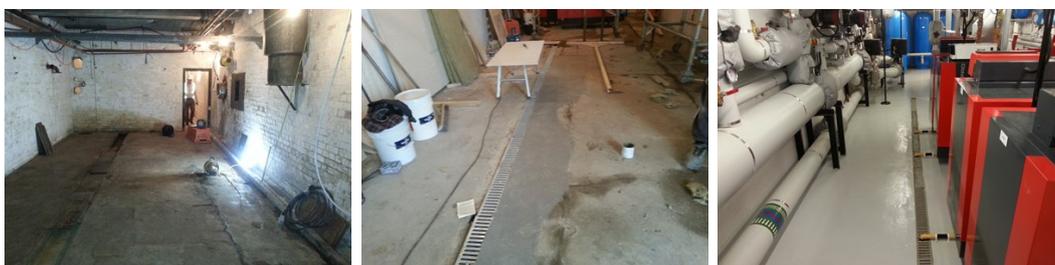
The existing concrete floor had many broken and damaged areas and the steep steps down into the basement were smooth and slippery

- \* Disused basement before ,
- \* Belzona 4111 and 4131 being installed to repair floor ,
- \* Completed plant room with floor coated with Belzona 5231 ,

The application was carried out in accordance to Belzona Know-How System Leaflets FPA-1 and FPA-8. Belzona 4111 and 4131 were used to repair and level the damaged concrete areas and then the steps and floor were coated with Belzona 5231.
