# BELZONA KEEPS THE FLOW GOING

**Industry:** General Industry  
**Application:** CEP-Centrifugal Pumps  
**Substrate:** Cast iron  
**Products:** \* Belzona 1111 (Super Metal) ,  
\* Belzona 1341 (Supermetalgilde) ,

**Customer Location:** Tire Manufacturer, Czech Republic  
**Application Date:** March 2015

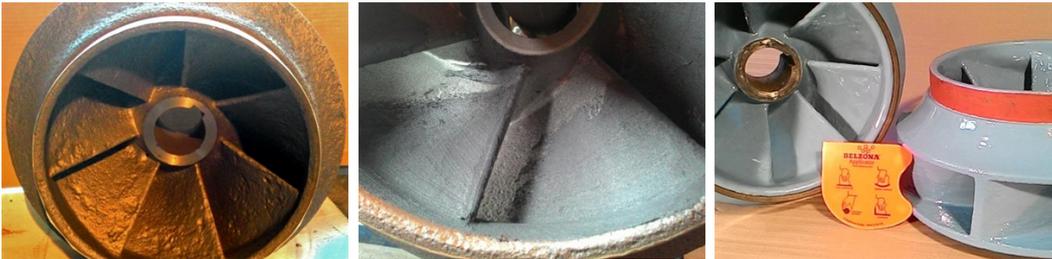
Impeller vanes on water pumps had been damaged by cavitation erosion corrosion, leading to reduced efficiency.

- \* The damaged impeller ,
- \* Surface profile being restored with Belzona 1111 ,
- \* Impellers finished with Belzona 1341 ,

Application was carried out in accordance with Belzona Know-How System leaflet CEP-10. Original profiles were restored with Belzona 1111 before applying two coats of Belzona 1341 to provide future erosion corrosion protection to the impellers.

The application of Belzona 1111 restored the original surface profile, allowing the client to avoid the expense of a total part replacement. The Belzona 1341 then added a layer of protection, preventing the recurrence of cavitation or corrosion damage and simultaneously improving flow rates thanks to the smooth surface.
