WASTEWATER CLARIFIER REPAIRS COMPLETED QUICKLY WITH BELZONA

ID: 6093

Customer Location: Water treatment plant, Tarbert, Scotland

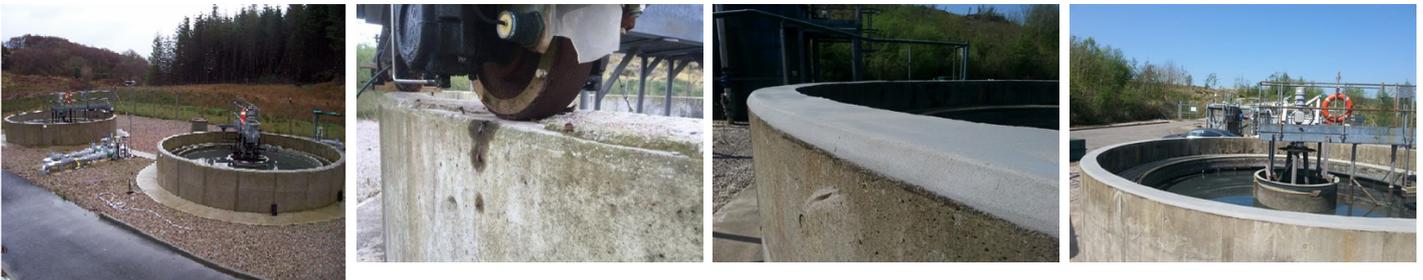
Photograph Descriptions

Running track on top of wall for distributor arm had been experiencing damage. The distributor wheels had caused impact & abrasion damage over time. Coupled with freeze/thaw, this had seriously damaged the substrate. Only a limited shutdown window was available for the repair.

- * The two clarifiers before work started ,
- * Damage caused by the bridge wheel ,
- * Belzona 4131 applied to the top of the wall ,
- * Completed application ,

Running track on two concrete clarifiers.

Using Belzona 4131, a repair could be completed in a fraction of the time it would take to knock down the clarifier walls & rebuild them. Belzona 4131's chemical & impact resistance will also stop the original problem from re-occurring.
