BELZONA REFURBISHES SPLIT CASE PUMP

ID: 6095

Customer Location: *Distillery, Glasgow, Scotland*
Application Date: *May 2016*

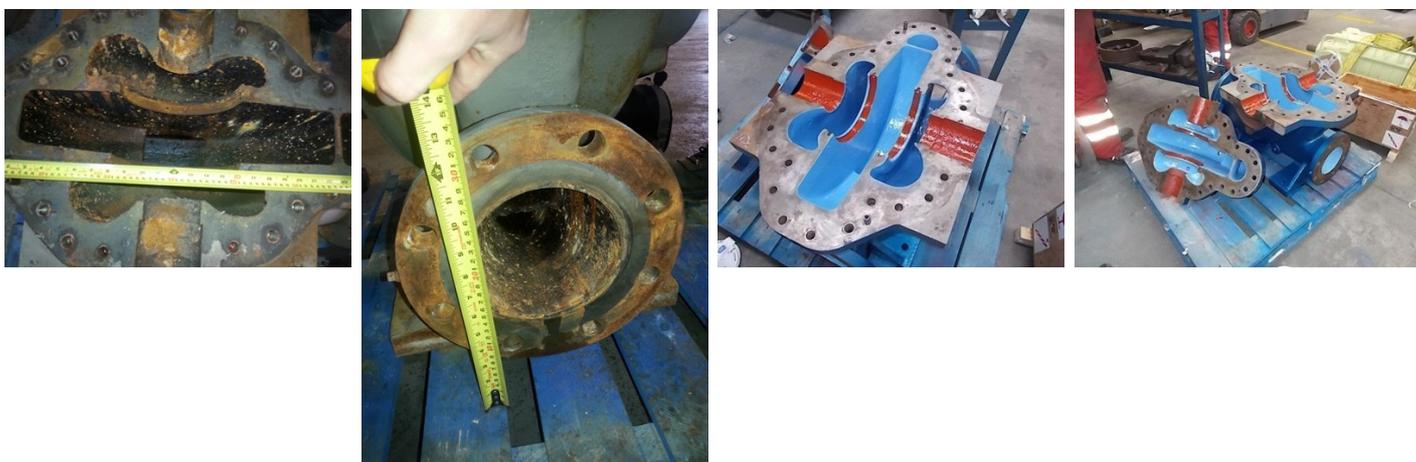
Photograph Descriptions

Pump had been experiencing erosion/corrosion. Damage had occurred to the existing coating & some of the underlying steel substrate had been eroded away. If another model of pump were to be installed in this instance the surrounding pipework would have to be modified.

- * Pump casing before ,
- * Damage before ,
- * Casing after application of Belzona 1341 ,
- * Completed application ,

The application was carried out in accordance with Belzona Know-How System Leaflets CEP-1 and CEP-3. The damaged areas around the wear rings were rebuilt with Belzona 1111 before the casing was coated with two coats of Belzona 1341.

Using this method the pump was repaired/protected & ready for service without the need for any modifications of the pipework associated with it. Due to the low film thickness of Belzona 1341, no major changes to the pump head are expected.
