BELZONA RECESSED LINING MARKING SURVIVES CONSTANT ABUSE

Industry: General Industry
Application: FPA-Floor Problem Areas
Substrate: Concrete
Products: * Belzona 5231 (SG Laminate) ,
* Belzona 9221 (Surefoot Aggregate White) ,

Customer Location: Waste Recycling Plant, UK
Application Date: 2009-2012

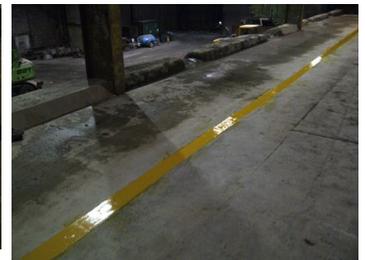
This leading waste handling company had many sites nationally, which all had problems with line marking. The heavy plant shovelling waste about would quickly destroy any line markings that were applied, and typically they would be ruined in a matter of days. Belzona worked with the client to devise a long lasting solution.

- * Heavy plant shovel operating on site ,
- * Trial area 1 year after application in 2009 ,
- * Recessed application of Belzona 5231 ,
- * Completed line marking on top deck in 2012 ,

Application was carried out using a modified version of Belzona Know-How System Leaflet FPA-4. A channel was cut into the floor about 160mm wide and 5mm deep. A self-levelling screed was made using Belzona 5231 and Belzona 9221 mixed 3:1 which was poured into the channel.

In 2009 Belzona applied trial areas of Belzona 4411 on the surface and also a recessed application of Belzona 5231. After 3 years the surface application had largely been scraped away, whereas the recessed application was still in very good condition. The recessed

solution was immediately taken up by the client and installed along the 37m of the top deck of this facility. Despite persistent abuse from the heavy plant shovels, it remains intact over 6 years later. Areas that only suffer foot traffic are still lined with Belzona 4411.
