RECESSED BELZONA SELF LEVELLING LINE MARKING

ID: 6098

Customer Location: Waste Recycling Plant, UK
Application Date: 2012

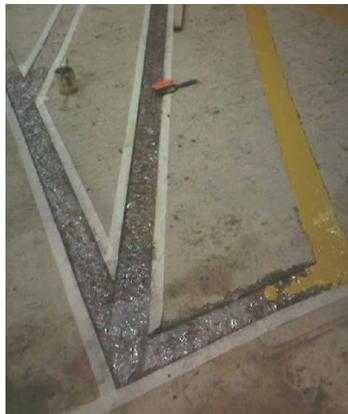
Line markings in the facilities of this leading waste handling company typically only lasted days before being destroyed by the heavy plant shovels. A previous Belzona trial had proved very successful and so was again chosen as the solution for this site entrance.

- * Entrance with lines recessed 5mm ,
- * Channels conditioned with Belzona 4911 ,
- * Line marking with Belzona 5231 ,

Application was carried out in accordance with Belzona Know-How System Leaflet FPA-4. A channel was cut into the floor about 160mm wide and 5mm deep. A self-levelling screed was mixed using 3:1 Belzona 5231 and Belzona 9221, before being poured into the channel.

This self-levelling mix of Belzona 5231 offered a cost effective and solvent free application that would not shrink. The recessed application has survived constant heavy traffic with shovels scraping over it as the waste is moved into the facility.
