# SUBTERRANEAN BELZONA SUPERWRAP II APPLICATION

ID: 6099

**Customer Location:** Petrochemical, Ayutthaya, Thailand  
**Application Date:** May 2016

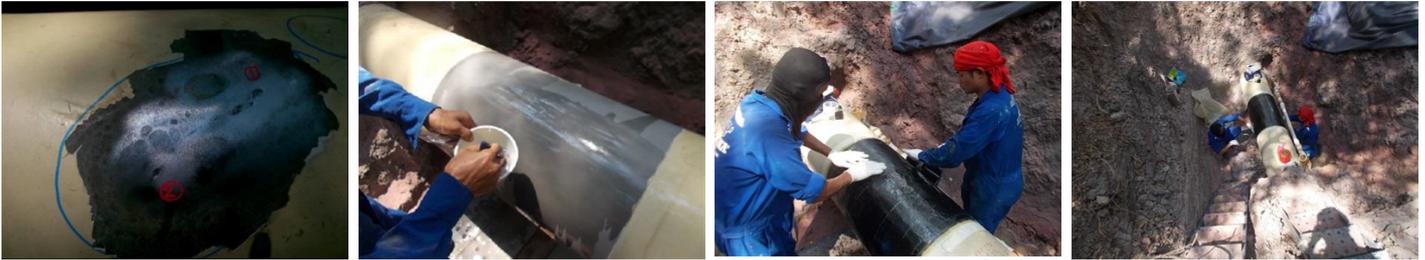
Inspection pigs had detected external local corrosion, which had created a thin-wall defect in the pipe.

- \* Thin-wall defect ,
- \* First layer of Belzona 1982 applied ,
- \* Layer of 9381 and 1982 being applied ,
- \* Completed application ,

Underground pipe with a design pressure rating of 100 bar(g) had developed thin-wall defect.

The application was carried out by a validated installer following the specific design generated for this application.
