BELZONA REPAIRS AND PROTECTS CONCRETE FLOOR AND U-DRAINS FROM CHEMICAL ATTACK

ID: 6106

Customer Location: *Chemical Plant, Burkville, AL, USA*
Application Date: *April 2016*

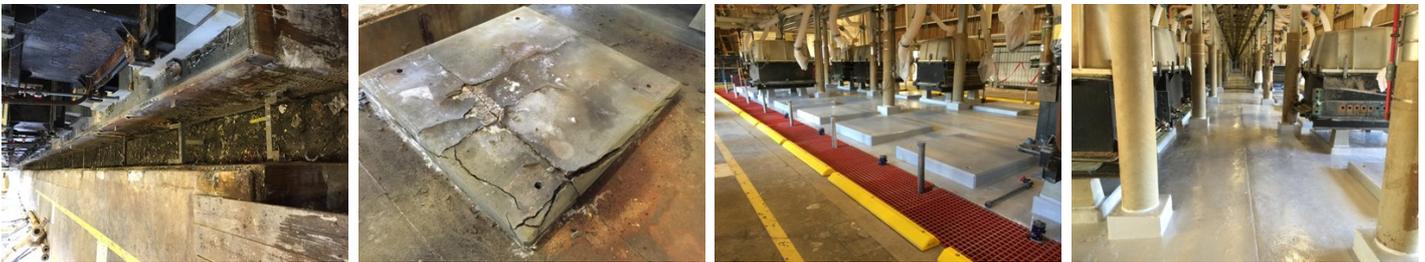
Photograph Descriptions

Chemical attack had caused damage to the concrete cell bases and multiple areas in the u-drains.

- * Damage on U-drains ,
- * Damaged diaphragm cell bases as a result of a chemical attack ,
- * Cell bases after the application ,
- * Completed application ,

The application was carried out in accordance with a modified version of Belzona Know-How System Leaflets FPA-1 for rebuilding worn and damaged floor surfaces and FPA-3 for protecting floors and drains against chemical attack. The concrete surface was prepared by removing loose and spalling concrete, pressure washing, abrasive blasting and diamond grinding. Belzona 4911 and 4131 were applied in accordance with Belzona's Instructions for Use. Two coats of Belzona 5892 at approximately 10 mils per coat were applied in accordance with Belzona's Instructions for Use. The entire application was completed per the details described in the Application Survey Report.
