BELZONA REBUILDS CAVITATED VANES

ID: 611

Industry: Power
Application: CEP-Centrifugal Pumps
Substrate: Cast iron
Products: * Belzona® 1311 (Ceramic R-Metal) ,
* Belzona® 1321 (Ceramic S-Metal) ,

Customer Location: Power plant, Egypt
Application Date: April 2004

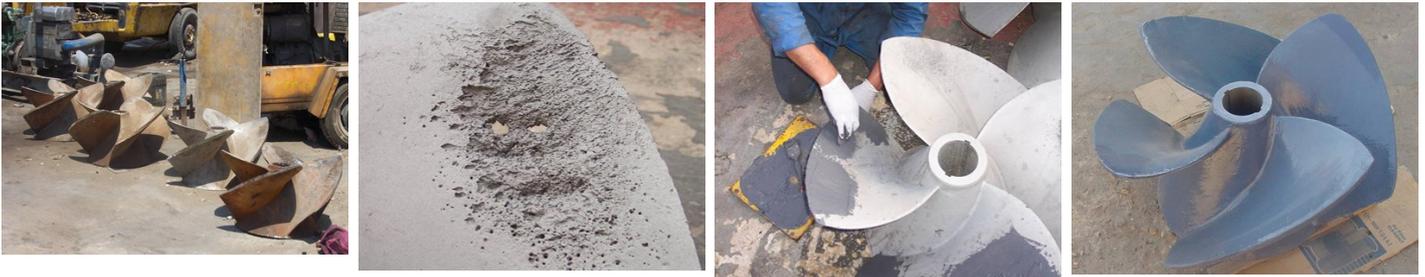
Photograph Descriptions

Severe cavitation caused holes, pittings and deformation in the profile of the vanes.

- * General view of the five impellers ,
- * The cavitated vanes ,
- * Rebuilding the vanes using Belzona® 1311 ,
- * Finished Impellers coated with Belzona® 1321 ,

Application was carried out in accordance with Belzona Know-How System Leaflets CEP-3 and CEP-5.

Belzona rebuilt the cavitation and pitting damage in the vanes restoring the correct profile using a simple technique, saving replacement costs and also providing more resistance to future cavitation.
