# OFFICE BALCONY ROOF REPAIRED WITH BELZONA

ID: 6133

**Customer Location:** Office building, Glasgow, Scotland  
**Application Date:** November 2013

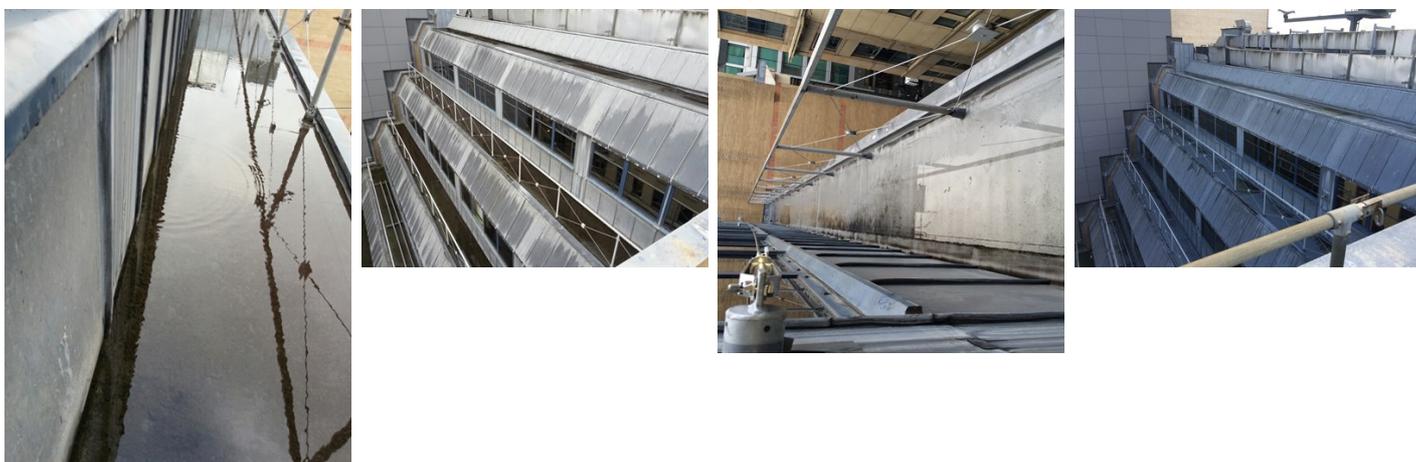
There were different substrates used for the roof & flashing, including felt and lead. There were also handrails & bolts to be removed that left gaps that had to be waterproofed. In particular, the balconies had developed ponding water, which, due to being north facing rarely dried up.

\* 1. Ponding water on the roof 2. Balcony sections before coating 3. Roof area after coating 4 Balcony sections after coating ,

A set of roof balconies had developed leaks, particularly around joints, seams and flashings.

Application was carried out in accordance with Belzona System Leaflets RPA-1, RPA-6 and RPA-8.

Coating the roof rather than removing the felt substrate saved the customer time & money and provided a seamless system able to cope with the regularly ponding water.
