OFFICE BALCONY ROOF REPAIRED WITH BELZONA

ID: 6133

Customer Location: Office building, Glasgow, Scotland
Application Date: November 2013

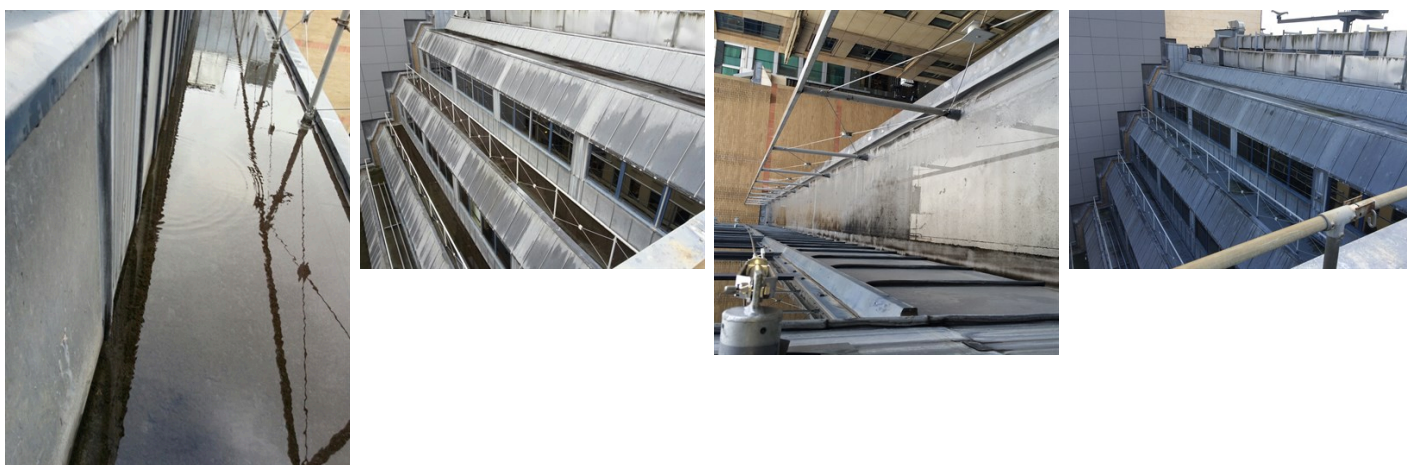
Photograph Descriptions

There were different substrates used for the roof & flashing, including felt and lead. There were also handrails & bolts to be removed that left gaps that had to be waterproofed. In particular, the balconies had developed ponding water, which, due to being north facing rarely dried up.

* 1. Ponding water on the roof 2. Balcony sections before coating 3. Roof area after coating 4 Balcony sections after coating ,

A set of roof balconies had developed leaks, particularly around joints, seams and flashings.

Application was carried out in accordance with Belzona System Leaflets RPA-1, RPA-6 and RPA-8.

Coating the roof rather than removing the felt substrate saved the customer time & money and provided a seamless system able to cope with the regularly ponding water.
