BELZONA BULKFILL RESTORES STEPS AT A HOSPITAL

Application: FPA-Floor Problem Areas

Four sets of stone steps at a hospital in Ontario Canada with large volume damage require cost effective and time critical repair.

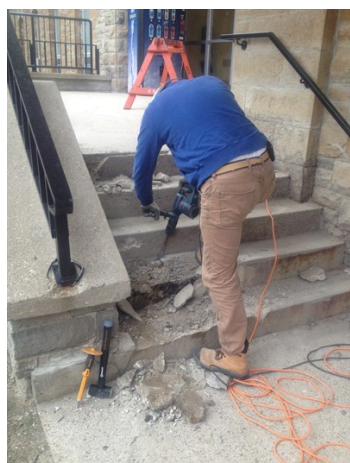
- * Preparing the stone back to firm substrate ,
- * Belzona 4154 being packed into former ,
- * Application of Belzona 4131 ,
- * Finished application with Belzona 5231 and 4411 ,

The damaged stone was removed back to a firm substrate. Due to the extent of the damage forms were created and Belzona 4154 was mixed with locally sourced aggregate and packed into place. Once cured the forms were removed and 1/4" of Belzona 4131 was applied over the stair treads and risers. To protect from further weathering and salt Belzona 5231 was applied over the steps with a high visibility yellow Belzona 4411 stripe at the edge of the step tread.
