BELZONA BULKFILL RESTORES STEPS AT A HOSPITAL

Customer Location: Penetanguishene, Simcoe County,
Ontario, Canada

Application: FPA-Floor Problem Areas

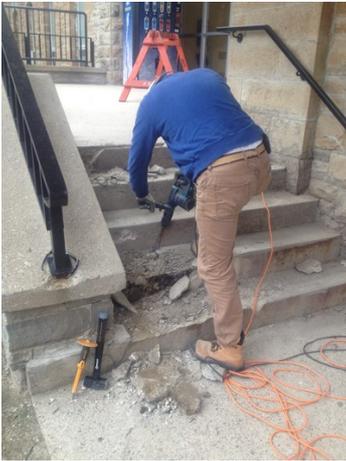
The steps had suffered severe damage and spalling caused by weathering, salt and freeze thaw effect. Large cracks and spalled stone were visible making the usage of the steps dangerous.

- * Preparing the stone back to firm substrate ,
- * Belzona 4154 being packed into former ,
- * Application of Belzona 4131 ,
- * Finished application with Belzona 5231 and 4411 ,

The damaged stone was removed back to a firm substrate. Due to the extent of the damage forms were created and Belzona 4154 was mixed with locally sourced aggregate and packed into place. Once cured the forms were removed and 1/4" of Belzona 4131 was applied over the stair treads and risers. To protect from further weathering and salt Belzona 5231 was applied over the steps with a high visibility yellow Belzona 4411 stripe at the edge of the step tread.
