BELZONA REBUILDS AND PROTECTS VANES

Industry: *Fluid Flow*
Application: *CEP-Centrifugal Pumps*
Substrate: *Cast iron*
Products: ** Belzona® 1311 (Ceramic R-Metal) ,*
** Belzona® 1321 (Ceramic S-Metal) ,*

Customer Location: *Water plant, Egypt*
Application Date: *February 2003*

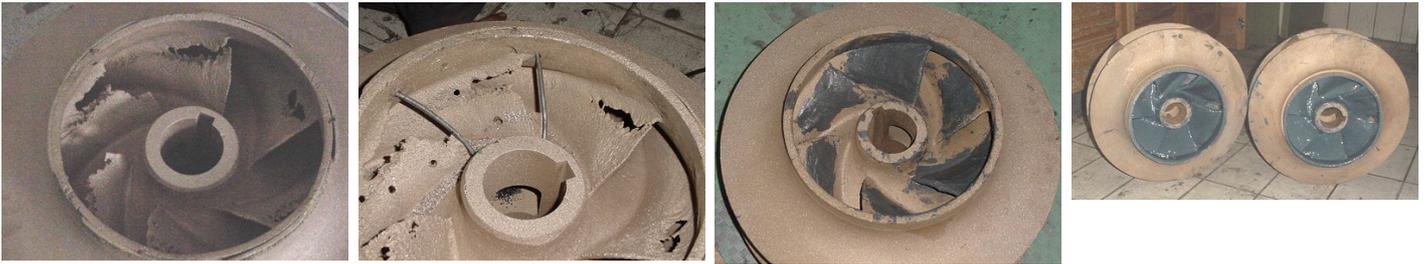
Photograph Descriptions

Vaness of the impellers were severely cavitated.

- * The cavitated vanes of the impeller ,
- * Preparing to rebuild the lost edges ,
- * Rebuilding the vanes ,
- * Vanes rebuilt and coated ,

Belzona rebuilt the cavitated vanes saving replacement cost of the impellers. It also provided resistance to cavitation by coating the vanes with Belzona® 1321. This application was repeated with other impellers later and the impellers are still in service.
