BELZONA BULKFILL REBUILDS HOSPITAL TRASH PAD

ID: 6140

Customer Location: Roanoke, VA, USA
Application Date: October 2015

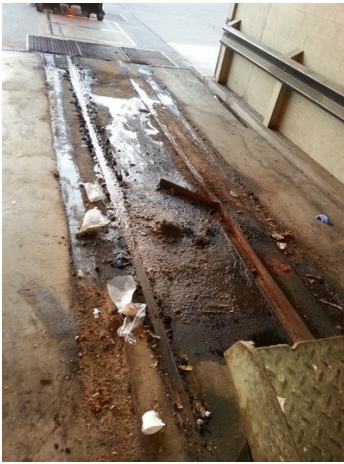
Concrete in roll-off area was deteriorating due to weight and dragging of trash containers. Large hole was a below ground conduit vault. Rain water was entering the vault area and causing electrical hazards.

- * 1. Damaged concrete of the trash pad ,
- * 2. Removing and scarification of the damaged concrete ,
- * 3. Application of Belzona 4154 and 4131 as a top coat ,
- * 4. Complete application ,
