BELZONA BULKFILL REBUILDS HOSPITAL TRASH PAD

ID: 6140

Concrete trash pad for roll-off dumpsters

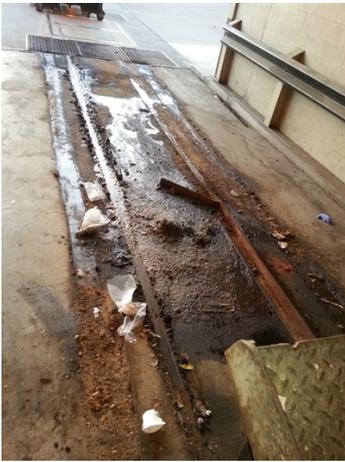
Concrete in roll-off area was deteriorating due to weight and dragging of trash containers. Large hole was a below ground conduit vault. Rain water was entering the vault area and causing electrical hazards.

- * 1. Damaged concrete of the trash pad ,
- * 2. Removing and scarification of the damaged concrete ,
- * 3. Application of Belzona 4154 and 4131 as a top coat ,
- * 4. Complete application ,
