# BELZONA PROTECTS NEW HOPPER FROM ABRASION

Industry: *Mining & Quarrying*  
Application: *SHM-Solids Handling Machinery*

Customer Location: *Cement plant, Croatia*  
Application Date: *April 2016*

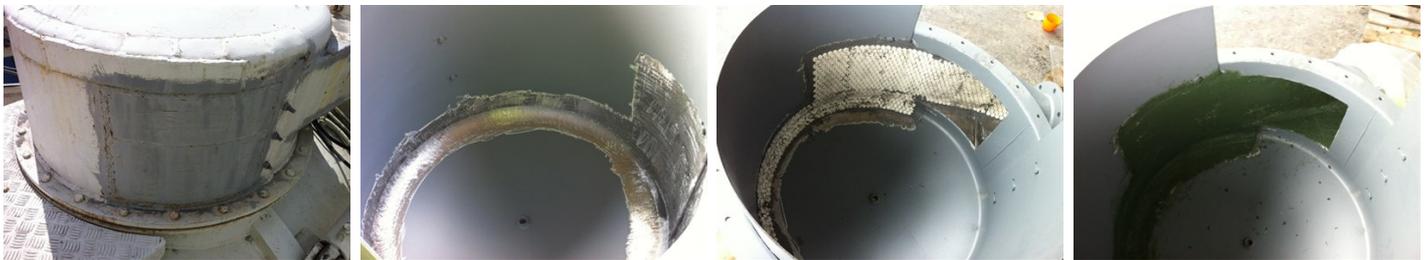
*The hopper is situated on top of the machine and one section suffers from severe abrasion. Structural failures on that section would cause safety and operational problems.*

\* 1. Damaged old hopper. Welding to critical section is visible from the outside 2. New hopper with surface prepared. 3. Belzona 9811 bonded in place using Belzona 1111 4. Grouting Belzona 9811 tiles with Belzona 1813. ,

The application was carried out in accordance with Belzona Know-How System Leaflet SHM-7

Premature failure of the hopper caused downtime and hopper needed to be repaired by welding. In order to prevent such failures in the future and extend working life of the hopper, customer was looking for a way to protect its critical section before installation. Belzona is already used on this machine (pipe elbow that is connected to the hopper), so customer decided to also use Belzona in this case.
