WATER STORAGE TANK UPGRADED WITH BELZONA COATING

ID: 6157

Customer Location: Oil production platform, UK North Sea
Application Date: June 2016

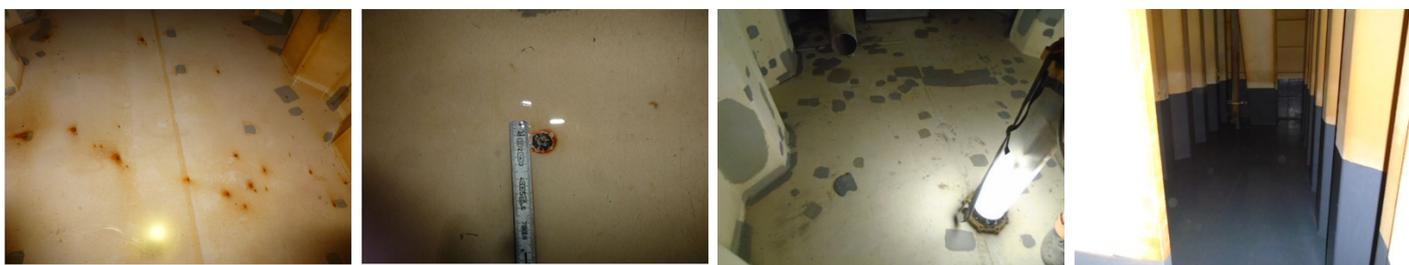
Photograph Descriptions

Tank was suffering localised pitting and coating breakdown on deck plates and beam edges. Superior erosion resistant coating required to protect the vessel from further corrosion.

* 1. Deck of tank showing areas affected by corrosion 2. Example of pitting on tank wall 3. Areas of corrosion and pitting repaired with Belzona 1111 4. View of completed application on water tank ,

Application was carried out in accordance with Belzona system Leaflet TCC-5. After preparing substrate by grit blasting, Belzona 1111 was used to rebuild the areas of pitting and corrosion, and then coated with Belzona 1321 to provide erosion-corrosion protection in the lower section of the tank. .
