# PRESS ROLL CRACK REPAIR WITH BELZONA

ID: 616

Industry: *Pulp & Paper*  
Application: *SHM-Solids Handling Machinery*

Substrate: *Hard rubber*  
Products: *\* Belzona® 1111 (Super Metal) ,*

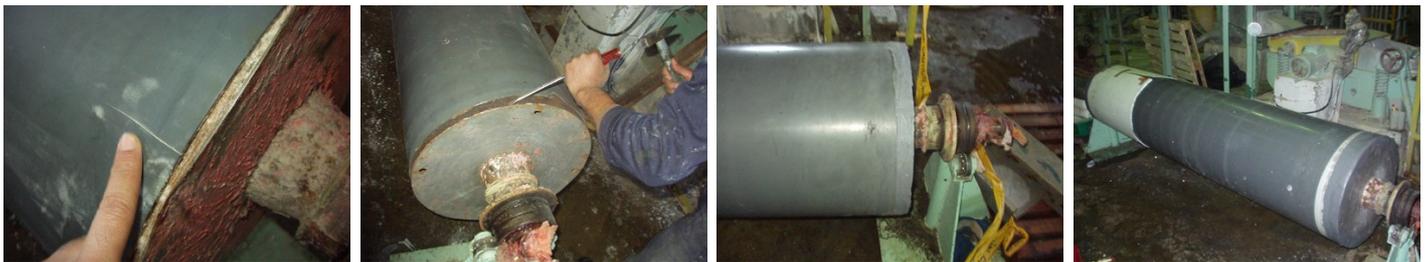
## Photograph Descriptions

*Crack in the hard rubber cover of the press roll. The crack was increasing over time.*

- \* The crack in the rubber cover ,
- \* Removing the cracked layer ,
- \* Belzona® 1111 applied to the roll ,
- \* Completed repair ,

Application was carried out in accordance with Belzona Know-How System Leaflet SHM-9. The cracked layer was removed then Belzona® 1111 applied and finally machined back to size.

Belzona® 1111 had similar hardness to the original hard rubber, was easy to machine and has good compressive strength to cope with the operating conditions.
