ACCESS STEPS REFURBISHMENT WITH BELZONA

ID: 6177

Customer Location: Research Facility, Melbourne, Australia
Application Date: October 2015

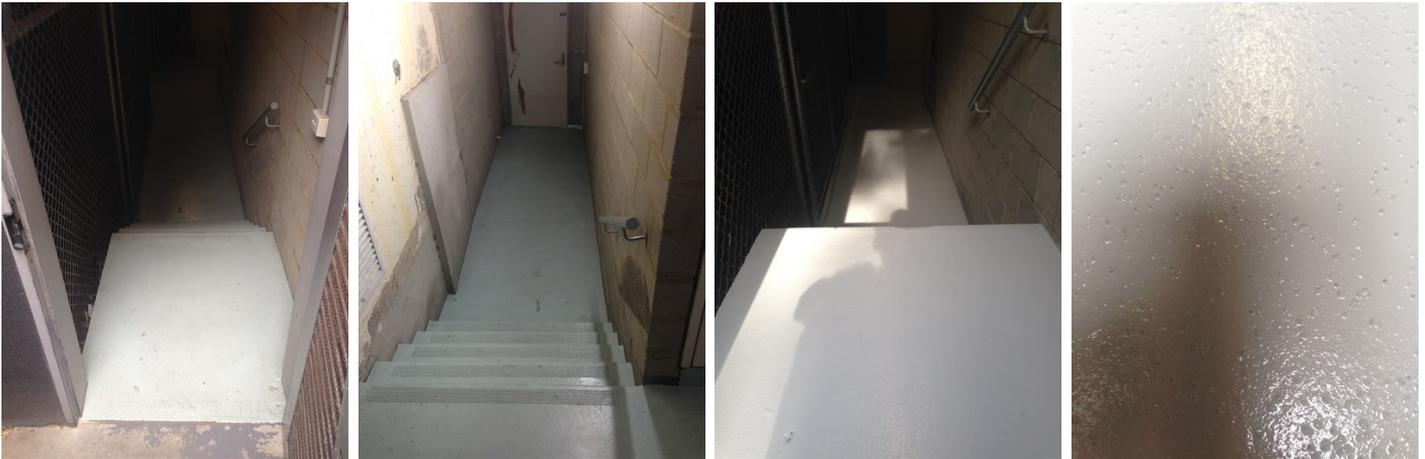
Photograph Descriptions

The access steps to the research facility had become worn over time making them prone to slip hazards, especially after periods of heavy rain which had been highlighted by a recent HSE audit.

* 1. Existing flooring 2. Existing flooring, alternate view 3. Finished application 4. Close up showing additional aggregate ,

Application was carried out in accordance with Belzona System Leaflet FPA-8. The existing sound coating was thoroughly abraded before applying the Belzona 5231 system. Additional aggregate was added between coats to provide a higher level of slip resistance.

Belzona 5231 was chosen because of its incorporated aggregate which provides a high level of slip resistance, combined with superior wear resistance. Its ability to be applied onto the manually prepared existing coating was also a prime consideration, as the sensitive research items within the building prohibited the use of any kind of mechanical tooling.
