ACCESS STEPS REFURBISHMENT WITH BELZONA

ID: 6177

Industry:	Buildings & Structures	Customer Location:	Research Facility, Melbourne, Australia
Application:	FPA-Floor Problem Areas	Application Date:	October 2015
Substrate:	Coated concrete		
Products:	* Belzona 5231 (SG Laminate) ,

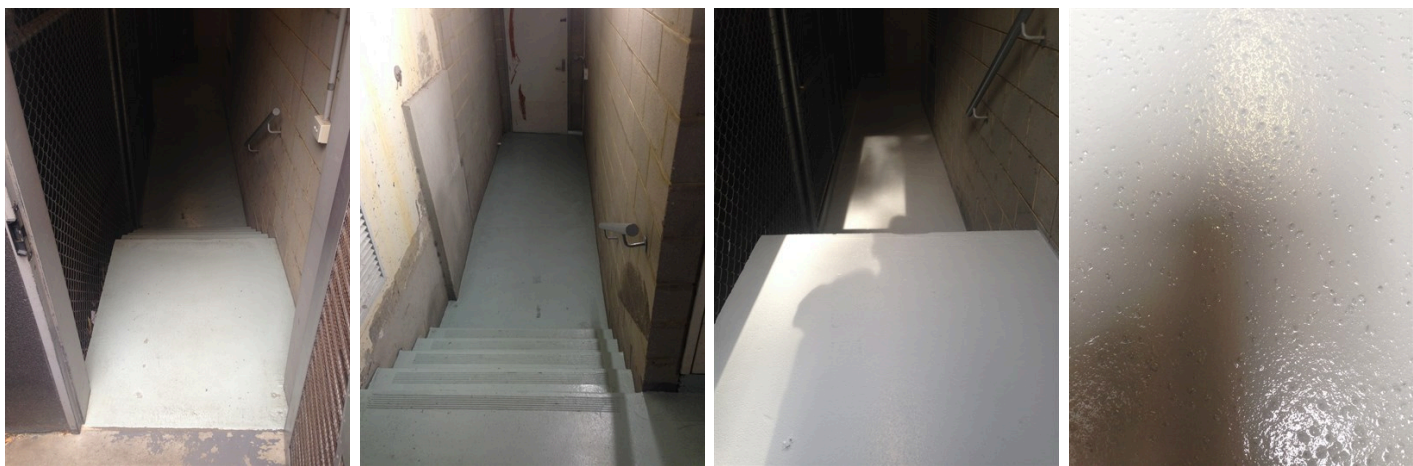
Photograph Descriptions

The access steps to the research facility had become worn over time making them prone to slip hazards, especially after periods of heavy rain which had been highlighted by a recent HSE audit.

* 1. Existing flooring 2. Existing flooring, alternate view 3. Finished application 4. Close up showing additional aggregate ,

Application was carried out in accordance with Belzona System Leaflet FPA-8. The existing sound coating was thoroughly abraded before applying the Belzona 5231 system. Additional aggregate was added between coats to provide a higher level of slip resistance.

Belzona 5231 was chosen because of its incorporated aggregate which provides a high level of slip resistance, combined with superior wear resistance. Its ability to be applied onto the manually prepared existing coating was also a prime consideration, as the sensitive research items within the building prohibited the use of any kind of mechanical tooling.
