BELZONA REFURBISHES WALKWAYS

Customer Location: Medical Research Centre, Melbourne, Australia

Application: FPA-Floor Problem Areas

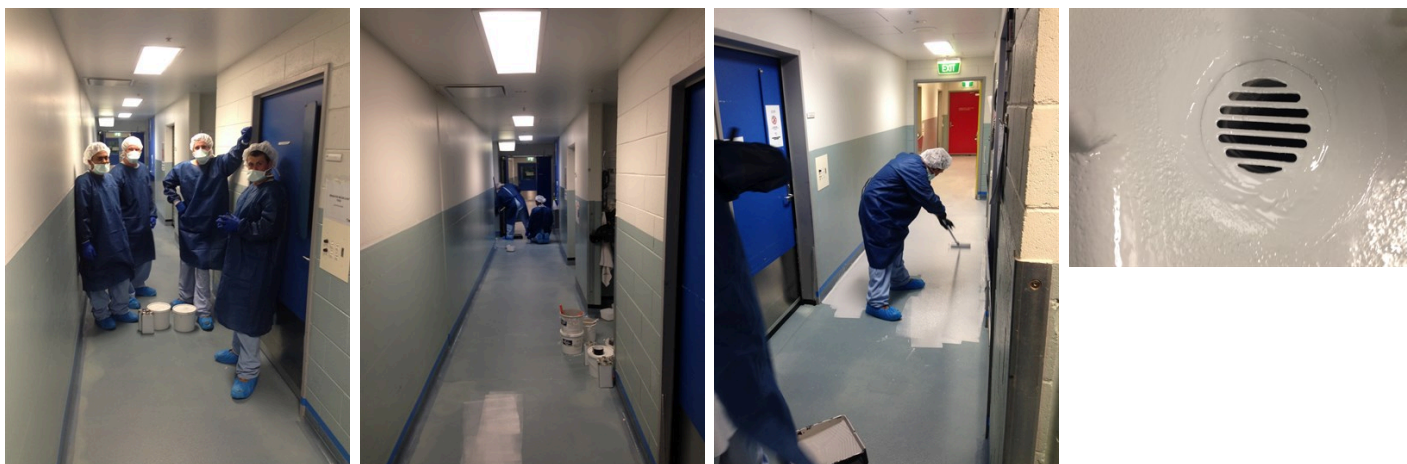
Photograph Descriptions

The existing coating had started to break down creating both a trip hazard and a cleanliness issue for the facility.

* 1. Floor prepared and masking complete 2. First coat underway 3. First coat almost complete 4. Close up of coating around drain

Application was carried out in accordance with Belzona System Leaflet FPA-8. The application was carried out over night. The coating was also applied partially up the walls to aid with cleaning of the floors.

The Belzona SG Laminate was chosen due to its solvent free nature and fast curing ability that allowed 2 coats to be applied in the short application window. The prime consideration was its ability to be applied to and bond onto the minimally prepared surface of the existing coating as mechanical preparation methods of any kind were prohibited.
