# DEIONIZER COATED WITH BELZONA

ID: 618

**Industry:** *Water / Wastewater*  
**Application:** *TCC-Tanks and Chemical Containment Areas*  
**Substrate:** *Carbon steel*  
**Products:** *\* Belzona® 5811 (Immersion Grade),*

**Customer Location:** *Medicine factory in Egypt*  
**Application Date:** *August 2004*

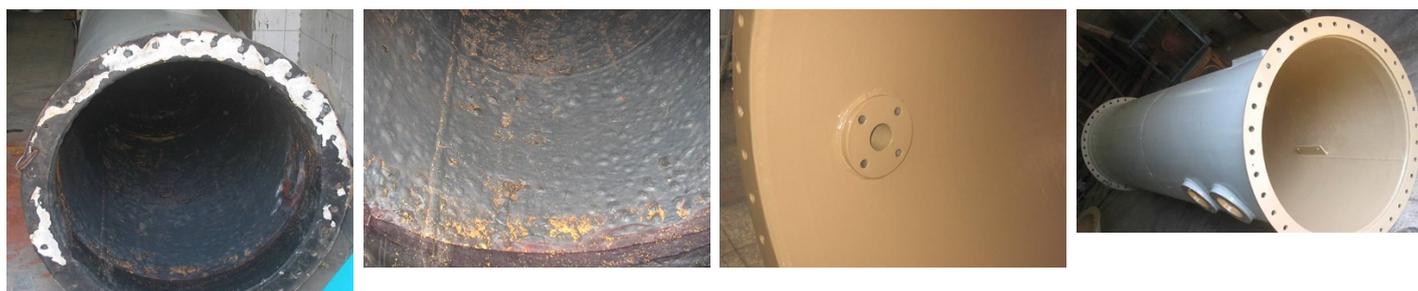
*Failure of rubber lining due to aging and chemical attack.*

- \* General view of the deionizer ,
- \* The failed rubber lining ,
- \* Deionizer from inside after coating ,
- \* Application completed ,

Rubber lining was removed then Belzona® 5811 was applied to provide long term protection to the deionizer. The deionizer was inspected after a year and found to be in perfect condition. More deionizers were then coated.
