DEIONIZER COATED WITH BELZONA

ID: 618

Industry: *Water / Wastewater*
Application: *TCC-Tanks and Chemical Containment Areas*
Substrate: *Carbon steel*
Products: ** Belzona® 5811 (Immersion Grade),*

Customer Location: *Medicine factory in Egypt*
Application Date: *August 2004*

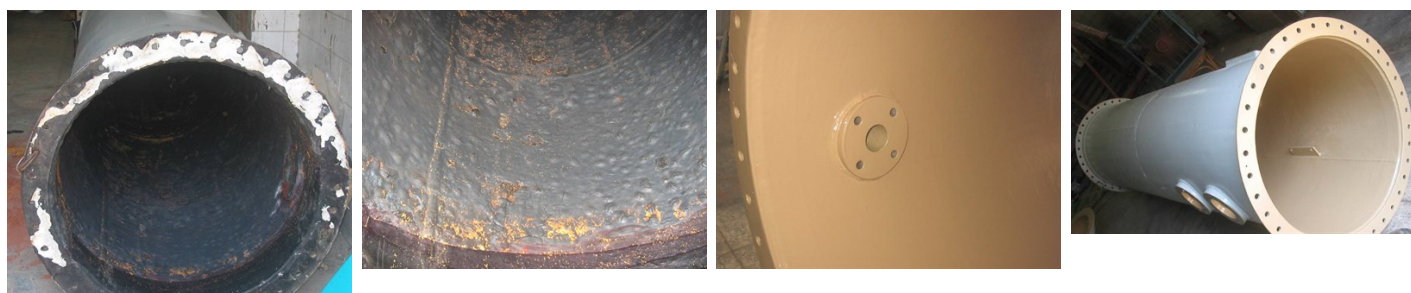
Photograph Descriptions

Failure of rubber lining due to aging and chemical attack.

- * General view of the deionizer ,
- * The failed rubber lining ,
- * Deionizer from inside after coating ,
- * Application completed ,

Application was carried out in accordance with Belzona Know-How System Leaflet TCC-5.

Rubber lining was removed then Belzona® 5811 was applied to provide long term protection to the deionizer. The deionizer was inspected after a year and found to be in perfect condition. More deionizers were then coated.
