BELZONA UPGRADES ACID BUND

Industry: Power
Application: TCC-Tanks and Chemical Containment Areas
Substrate: Concrete
Products: * Belzona 4111 (Magma Quartz) ,
* Belzona 4311 (Magma CR1) ,

Customer Location: Power Station, Queensland, Australia
Application Date: June 2008

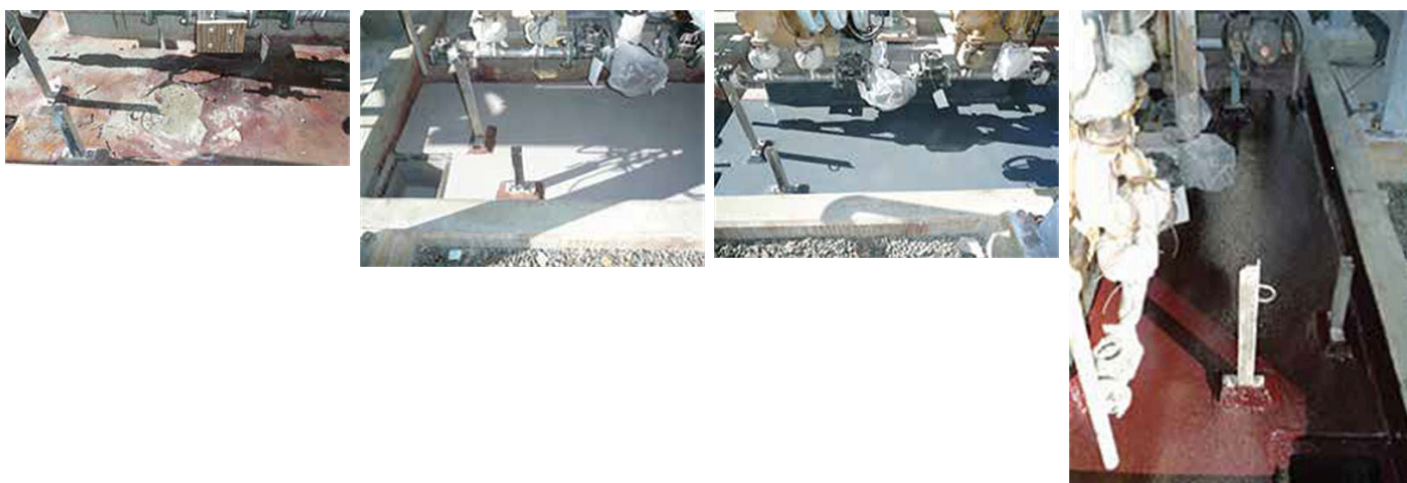
Photograph Descriptions

Spills of sulphuric acid over many years had significantly damaged the containment capabilities of the bund leaving it questionable about whether it could contain a major spill.

* 1. The badly damaged bund area 2. The bund re-profiled using Belzona 4111 3. The first coat of Belzona 4311 applied 4. The completed application ,

Application was carried out in accordance with Belzona System Leaflets TCC-9 and TCC-15. After removing damaged sections of old coating, the underlying concrete was neutralised using HP water and bicarbonate of soda. After drying damaged areas of concrete were rebuilt with belzona 4111 before coating overall with Belzona 4311 system.
