CAUSTIC BUND REFURBISHED WITH BELZONA

ID: 6184

Customer Location: Power Station, Queensland, Australia
Application Date: June 2008

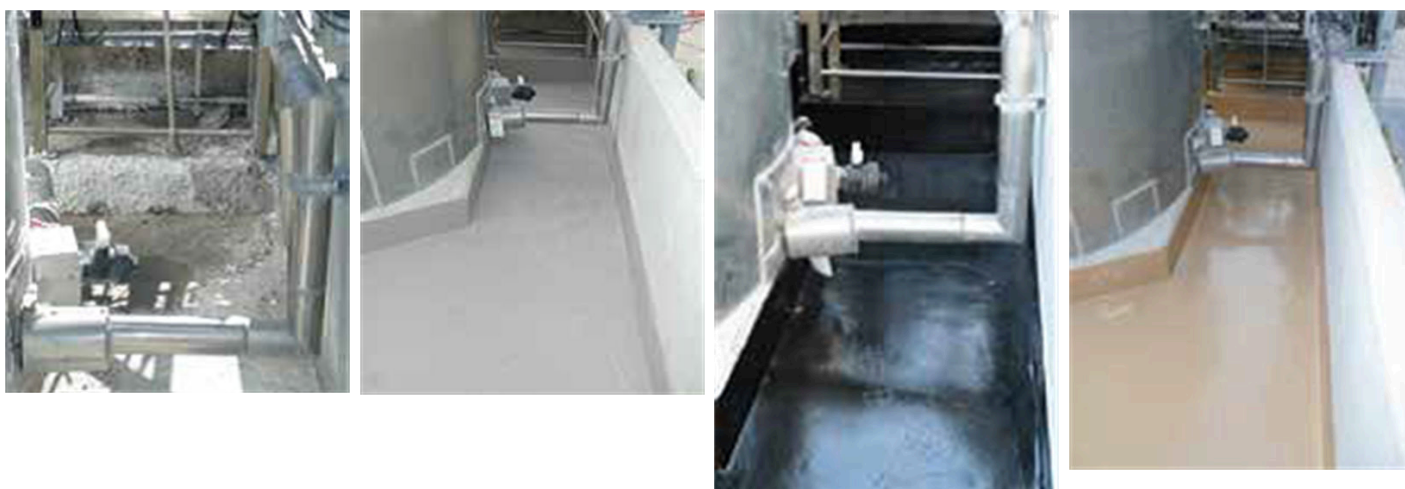
Photograph Descriptions

Spills of Caustic soda over many years had caused serious deterioration of the concrete floor and support plinths under the valves.

* 1. The damaged bund 2. Floor rebuilt and profiled with B4111 3. 1st coat of Belzona 5811 applied 4. 2nd coat of Belzona 5811 applied to complete the application ,

Badly damaged concrete and support plinths in a Caustic Containment area.

Application was carried out in accordance with Belzona System Leaflets TCC-9 and TCC-15. After removing damaged concrete the area was high pressure water washed and neutralised with dilute hydrochloric acid. When dry, damaged areas of concrete were rebuilt with Belzona 4111 before coating with Belzona 5811 to provide overall protection.

Belzona materials were chosen as they could be applied with the minimum of downtime for the 24/7 operating facility and still provide the required level of strength and chemical resistance required for the bund to provide years of trouble free service.
