BELZONA ELIMINATES TRIP HAZARD FROM DRAIN COVERS

Industry: Buildings & Structures
Application: FPA-Floor Problem Areas
Substrate: Concrete
Products: * Belzona 4111 (Magma Quartz) ,
* Belzona 4411 (Granogrip) ,

Customer Location: Shopping centre, Bankstown, Australia
Application Date: May 2004

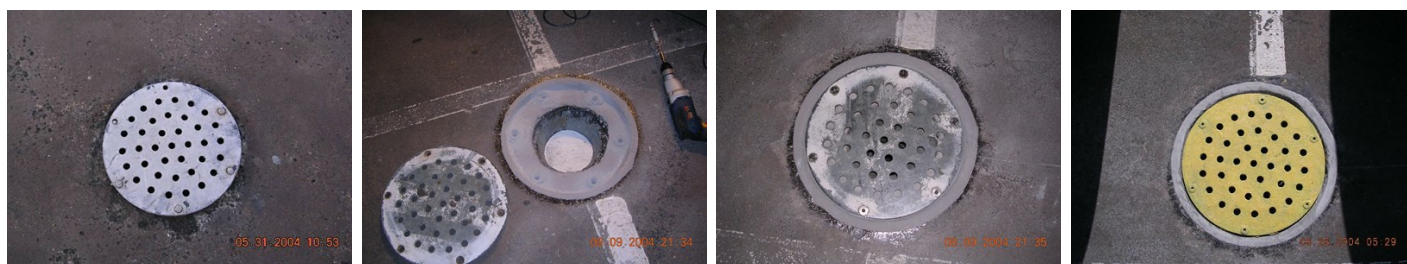
Photograph Descriptions

Existing drain covers were proud of surface creating a potential trip hazard.

- * 1. The raised drain plate ,
- * ,
- * 2. Belzona 4111 to rebuild drain ,
- * ,
- * 3. The plate fixed in place ,
- * ,
- * 4. Coated with Belzona 4411 ,

Application was carried out in accordance with Belzona Know- How System leaflets FPA-1 & FPA-8. Concrete was ground away and Belzona 4111 used to re-install plates at ground level. Plates were then coated with Belzona 4411 Granogrip to provide slip resistance.

The finished outcome eliminated the trip hazard and installation did not impact on normal operations around the shopping centre.
