BELZONA SEALS HIGH RISE ROOF

Customer Location: Commercial property, Brisbane, Queensland, Australia

Application: RPA-Roof Problem Areas

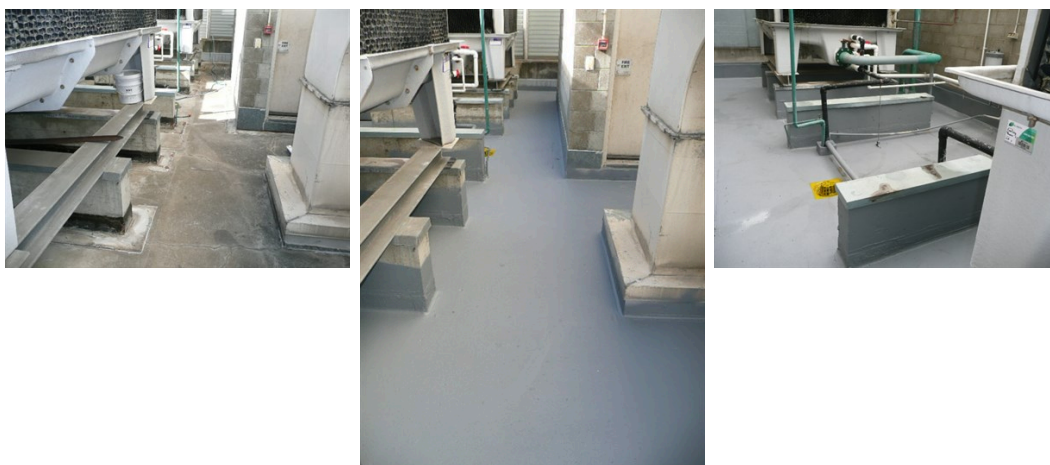
Photograph Descriptions

Water was leaking into the offices below and required a waterproof solution.

* 1. The roof prior to application 2. The finished coating 3. Alternate view of the sealed area ,

Concrete deck around cooling tower on the roof of a high rise building.

The application was carried out in accordance with Belzona System Leaflet RPA-1. The concrete was power washed to remove all dirt and detritus. Cracks that were revealed following the cleaning were then filled and sealed using Belzona 4151. The entire roof area was then coated with a fully reinforced Belzona 3111 system.
