# DAMAGED RUBBER LINING RESTORED

**Industry:** Water / Wastewater  
**Application:** TCC-Tanks and Chemical Containment Areas  
**Substrate:** Rubber and carbon steel.  
**Products:** \* Belzona® 2221 (MP-Fluid Elastomer) ,

**Customer Location:** Water treatment plant, Egypt  
**Application Date:** October 2001

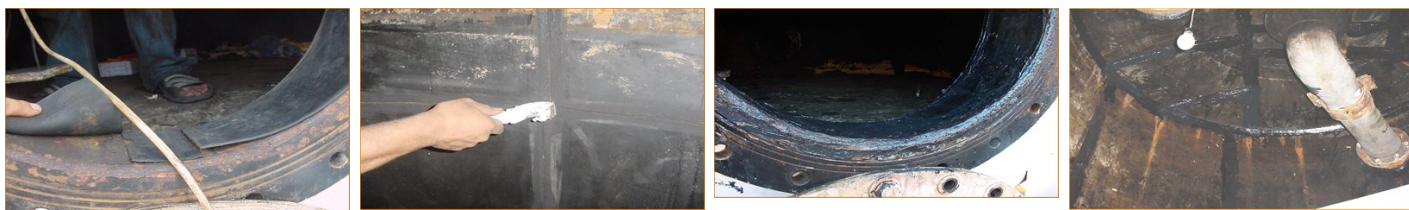
*Peeled-off lining at welding edges causing under lining corrosion due to sea water penetration between the rubber sheets.*

- \* Peeled-off lining ,
- \* Surface preparation of rubber at the welded seams areas ,
- \* Problem solved ,
- \* Sealed seams ,

Application was carried out in accordance with Belzona Know-How System Leaflet TCC-3.

Belzona performed easy, onsite repair of the existing lining. No new lining is required and all seams between the rubber sheets were well sealed and protected.
