# BELZONA REPAIRS CONCRETE AFTER BOLLARD REMOVAL

Industry: *Buildings & Structures*  
Application: *FPA-Floor Problem Areas*  
Substrate: *Concrete*  
Products: *\* Belzona 4111 (Magma Quartz) ,*

Customer Location: *Shopping Centre, Bankstown, Australia*  
Application Date: *September 2004*

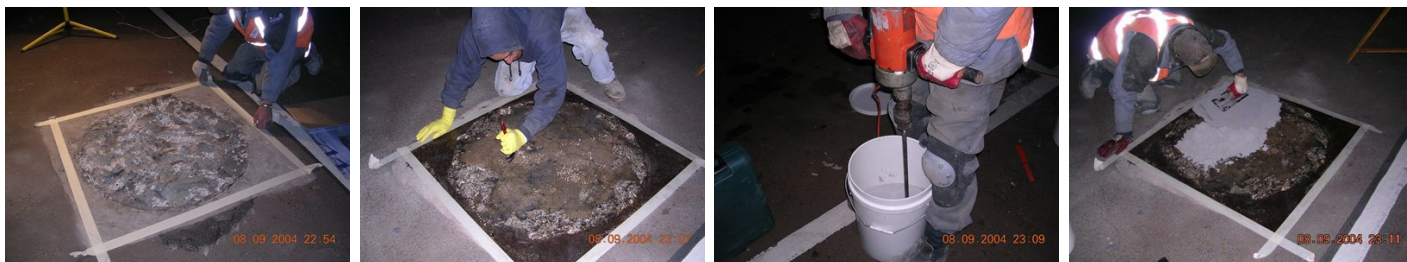
## Photograph Descriptions

*Removal of bollards left rough concrete substrate that was a trip hazard.*

- \* 1.Damaged concrete ,
- \* ,
- \* 2.Conditioner applied ,
- \* ,
- \* 3.Mixing Belzona 4111 ,
- \* ,
- \* 4. Applying Belzona 4111 ,

Damaged concrete in 48 areas where bollards were removed

Application was carried out in accordance with Belzona Know How System Leaflet FPA-1.

Ability to feather edge the Belzona 4111 enabled damaged areas to be quickly and simply levelled to eliminate trip hazard.
