BELZONA REPAIRS CONCRETE AFTER BOLLARD REMOVAL

ID: 6190

Customer Location: Shopping Centre, Bankstown, Australia
Application Date: September 2004

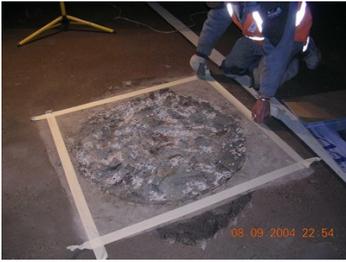
Removal of bollards left rough concrete substrate that was a trip hazard.

- * 1. Damaged concrete ,
- * ,
- * 2. Conditioner applied ,
- * ,
- * 3. Mixing Belzona 4111 ,
- * ,
- * 4. Applying Belzona 4111 ,

Damaged concrete in 48 areas where bollards were removed
