BELZONA KEEPS TENANTS DRY AND HAPPY

Customer Location: office complex, Brisbane, Queensland, Australia

Application: RPA-Roof Problem Areas

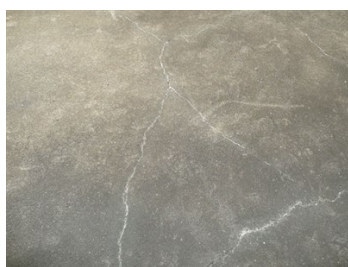
* 1. Original roof condition 2. Cracks in roof 3. Defects in the roof that needed repair 4. The finished application after application of the Belzona 3111 system ,

Application was carried out in accordance with Belzona System Leaflet RPA-1. After high pressure washing and drying the roof, cracks and defects revealed during the cleaning process were filled using the Belzona 4151 or Belzona as appropriate. A fully reinforced Belzona 3111 system was then applied over vthe entire roof area.

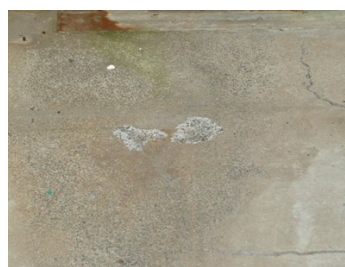
Cracks in the flat roof were allowing water to penetrate into the offices below.
