# BELZONA KEEPS TENANTS DRY AND HAPPY

Application: *RPA-Roof Problem Areas*

High Rise Office complex in the Brisbane Central Business District.

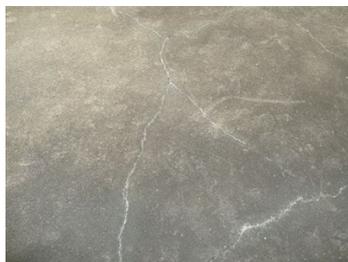
*Cracks in the flat roof were allowing water to penetrate into the offices below.*

\* 1. Original roof condition 2. Cracks in roof 3. Defects in the roof that needed repair 4. The finished application after application of the Belzona 3111 system ,

Application was carried out in accordance with Belzona System Leaflet RPA-1. After high pressure washing and drying the roof, cracks and defects revealed during the cleaning process were filled using the Belzona 4151 or Belzona as appropriate. A fully reinforced Belzona 3111 system was then applied over vthe entire roof area.
