BELZONA KEEPS TENANTS DRY AND HAPPY

Customer Location: office complex, Brisbane, Queensland, Australia

Application: RPA-Roof Problem Areas

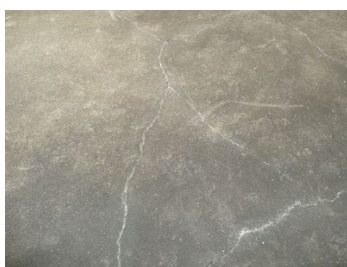
Cracks in the flat roof were allowing water to penetrate into the offices below.

* 1. Original roof condition 2. Cracks in roof 3. Defects in the roof that needed repair 4. The finished application after application of the Belzona 3111 system ,

Application was carried out in accordance with Belzona System Leaflet RPA-1. After high pressure washing and drying the roof, cracks and defects revealed during the cleaning process were filled using the Belzona 4151 or Belzona as appropriate. A fully reinforced Belzona 3111 system was then applied over the entire roof area.
