# BELZONA SQUARES THE CORNER

ID: 6198

Customer Location: Shopping centre, Brisbane, Australia

Damaged wall at a local shopping centre

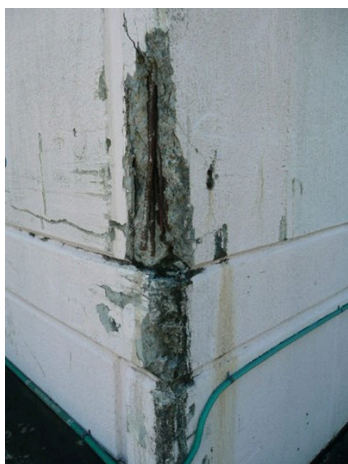
A delivery truck had reversed into the wall of the shopping centre, damaging the wall and exposing the reinforcement.

\* 1. Close up of the original damage 2. Crack stabilisation complete 3. Rebuild of the damage underway 4. The completed application ,

Application was carried out in accordance with Belzona System leaflet WPA-4. All loose material was removed and the exposed reinforcement bars cleaned to remove all rust. The remaining cracks in the wall were stabilised and then injected with the Belzona 4151. Once the Belzona 4151 had cured, the cracks were vee'd out and filled using the Belzona 4111. The damaged areas were also rebuilt using the Belzona 4111 to restore the original profile.
