BELZONA REFURBISHES LOADING DOCK

ID: 6199

Customer Location: Business complex, Brisbane, Queensland, Australia

Application: FPA-Floor Problem Areas

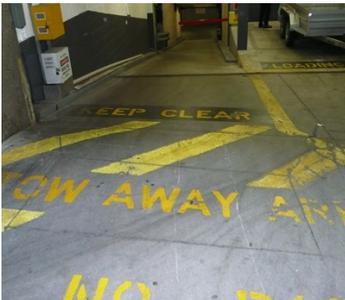
The Loading dock and car park were old and in need of a facelift as all of the original coating had been worn away.

* 1. The original condition of the floor area 2. Surface preparation in progress 3. A few small touch ups 4. The finished application showing the coated floor and reinstated lines, wording and chevrons ,

The application was carried out in accordance with Belzona System Leaflets FPA-4 and FPA-8. The floor area was prepared using a dustless diamond grinder then coated with 2 coats of the Belzona 5231. The line markings, chevrons and wording were then reinstated using Belzona 4411 in a single coat of safety yellow.
